TECHNICAL REPORT ARCCB-TR-92033

**FAILURE ANALYSES OF  
M3A1 BASEPLATE FOR 81-MM MORTAR 252**

STEVE TAUSCHER

JULY 1992

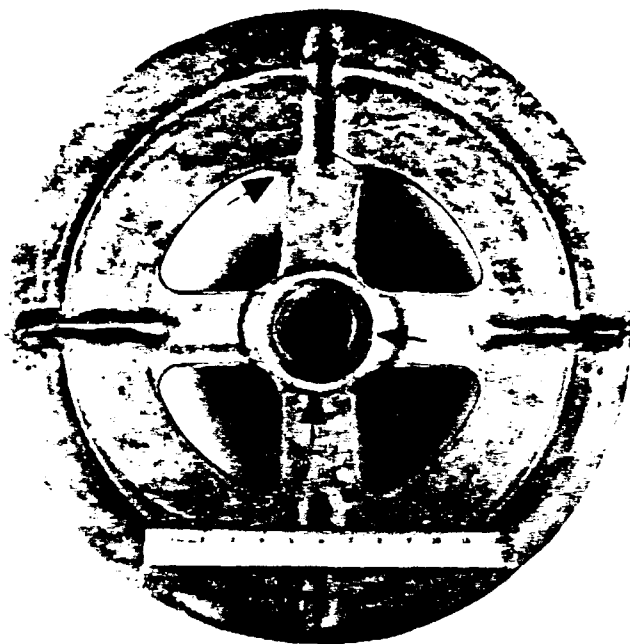
A visual examination of the baseplate (Figures 1 through 4) and of the fracture surfaces was conducted to identify any material and/or forging defects as well as to characterize the type of failure, i.e., fatigue, ductile, brittle, etc. An examination was also conducted to determine the origin of failure, if possible. Three fracture surfaces were created during the failure; two on the spades (Figures 2 and 3), one-third of the way from the hub to the outer ring, and one between the fillets of two adjacent triangularly-shaped holes (Figures 2 and 4). These locations have been previously identified as the areas of highest stress (ref 1), and have been the locations of cracking initiation in previous baseplate failures (ref 2), as well as fatigue-tested baseplates (ref 3).

Figure 1. Arrows pointing out cracks and fracture surfaces on M3A1 baseplate.

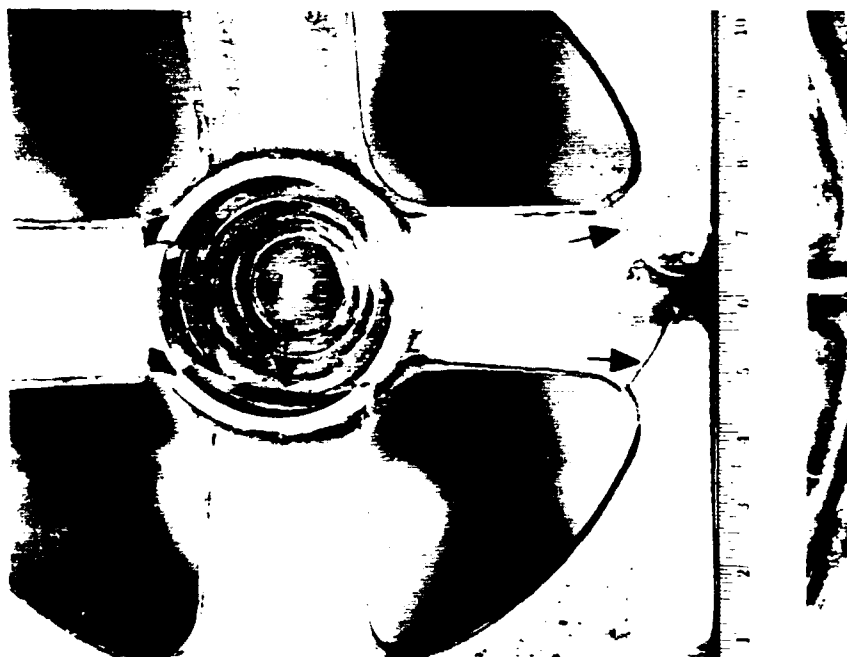
Figure 2. Closer view of same baseplate.

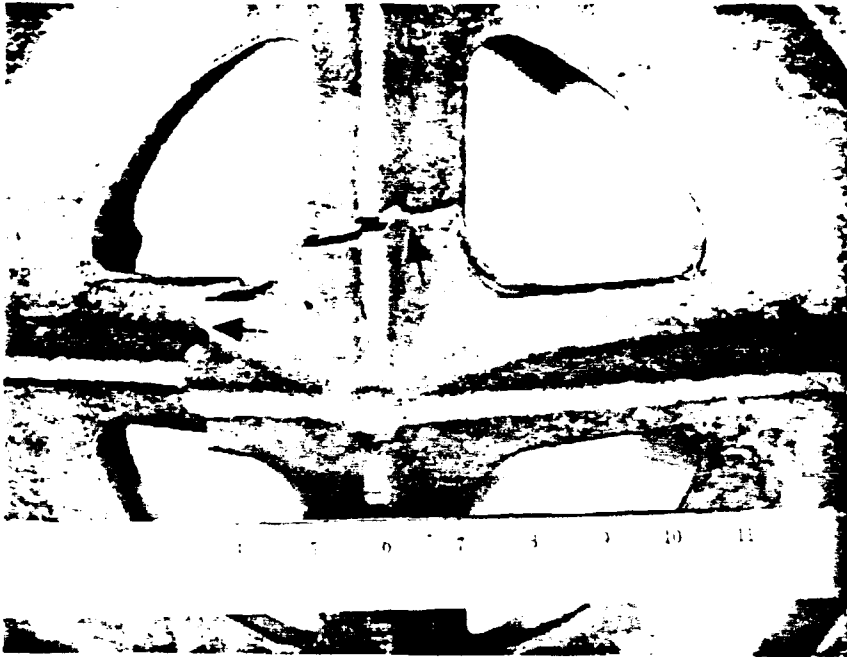
Figure 3. View of fracture through spade from underside of baseplate.

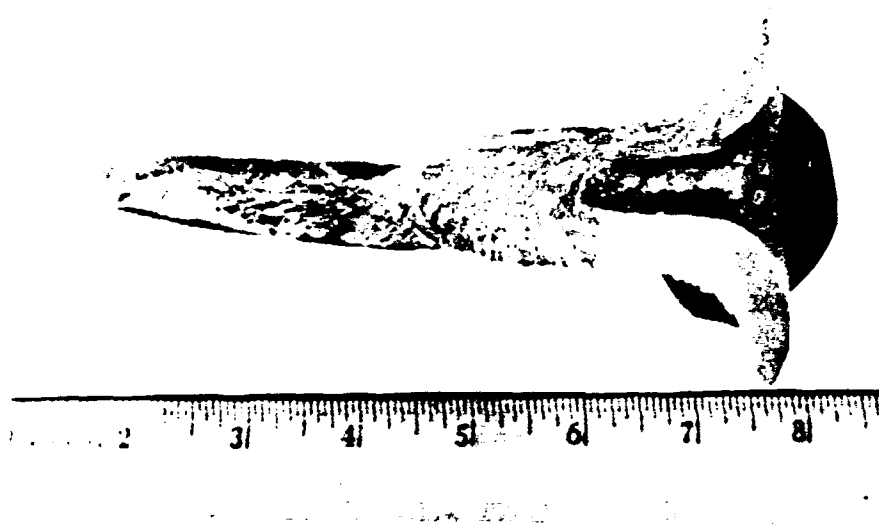
Examination of the fracture surface at the hole fillets revealed chevron-type markings again which indicated that the fracture had initiated on one side and proceeded in a fast unstable manner through the spade to the other fillet. Close examination of the fracture origin, as determined by the chevron-type markings, did not reveal a pre-existing material or forging defect. Also, under stereoscopic examination, there was no evidence of a pre-existing fatigue crack. The presence of shear lips on this fracture surface also suggests a relatively ductile failure. Finally, a dye-penetrant inspection of the entire baseplate did not reveal any other cracks.

Figure 7. Fracture surface at the fillet.

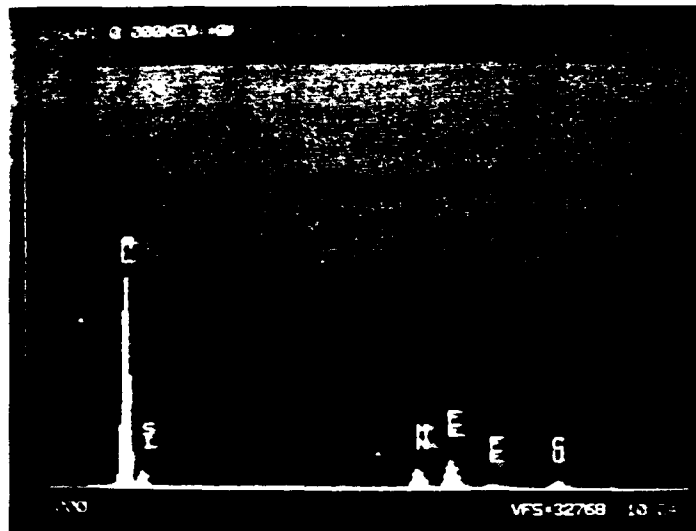
Scanning electron microscopy (SEM) was utilized for a micro-examination of the fracture origins for pre-existing defects and to characterize the fracture mode. All three fracture surfaces were examined. Again, there was no evidence of a material or processing defect. Further, there was no fractographic evidence of a corrosion-assisted cracking process or fatigue striations. Figure 9 is a fractograph that shows microvoid formation and void enlargement about angular particles. This is a characteristic of a ductile fracture mode under high load. Several particles in the fracture surface were analyzed using energy dispersive spectroscopy (EDS) and were found to contain aluminum, silicon, iron, and manganese (Figure 10). The particles were thus identified as  $(\text{FeMn})_3\text{SiAl}_{12}$ , which is a particulate common to 2014-T6 aluminum alloy.

Figure 10. EDS analysis of angular particles shown in Figure 9.

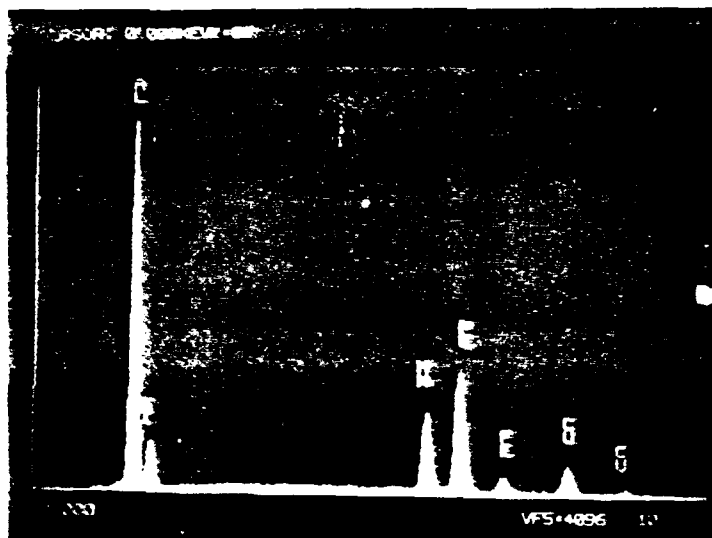
EDS was utilized to identify the composition of the particles shown in Figure 11. Figures 14 through 18 illustrate the elements found in particles on the polished and etched surface of a metallographic specimen. This analysis of elements, coupled with the gray levels revealed by Keller's reagent in optical microscopy, identified the larger particle constituents as  $\text{CuAl}_2$ ,  $(\text{FeMn})_3\text{SiAl}_{12}$ , and  $\text{Cu}_2\text{Mg}_8\text{Si}_6\text{Al}_5$ .

Figure 15. EDS analysis of microstructural constituents shown in Figure 14.

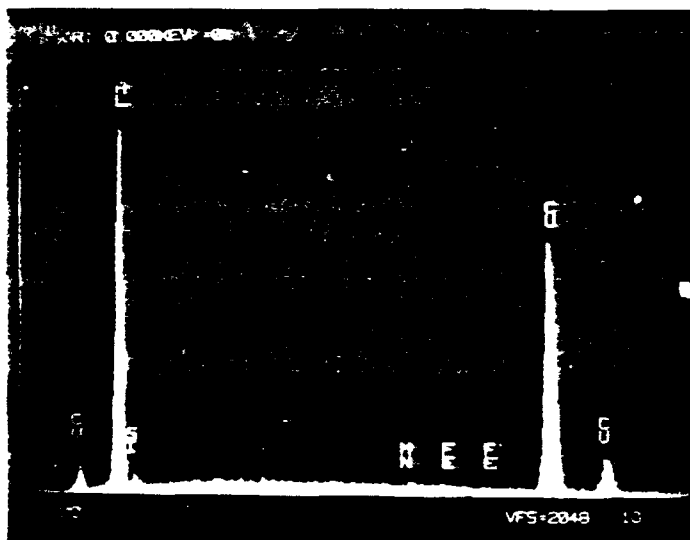
Figure 17. EDS analysis of white microstructural constituent shown in Figure 16.

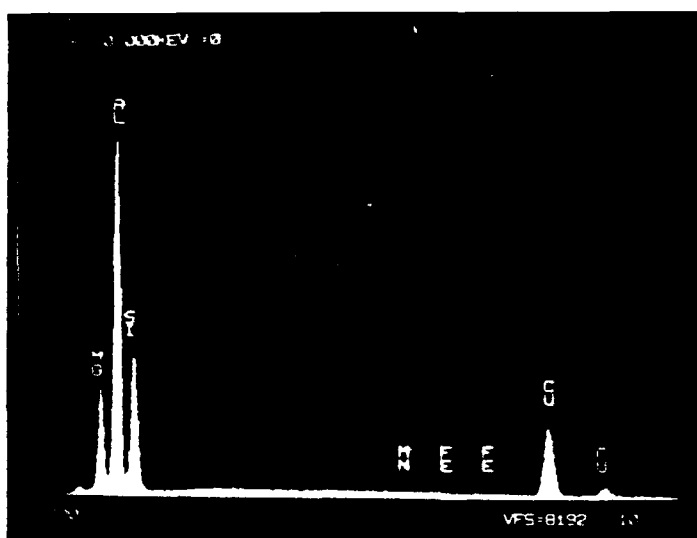
Figure 18. EDS analysis of small gray microstructural constituent shown in Figure 16.
